Swarf staining

Technical Bulletin 5

August 2019. Revision 8

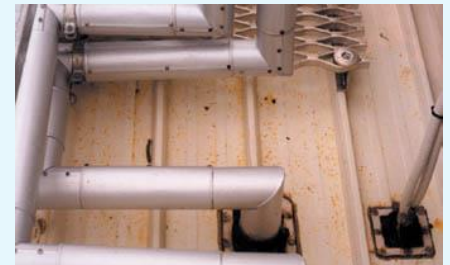
Many swarf staining problems arise not only from installers, but also from following trades working in the vicinity (see Figure 1 for example). Architects, builders and project managers need to be aware of this possibility and warn contractors accordingly.

Figure 1: Swarf staining
