Swarf staining of steel profiles

Technical Bulletin 5

June 2019. Revision 7
This issue supersedes all previous issues.

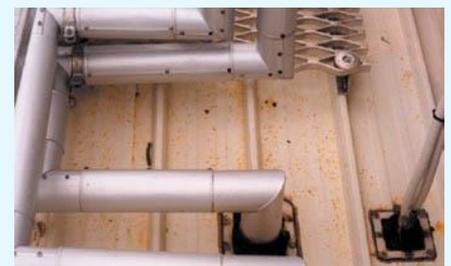
Swarf particles, if left on the surface, will corrode and cause rust stains which will detract from the finished appearance of the product. These stains are often mistaken for early deterioration of the roofing and walling.

Fresh swarf stains are characterised by small red-brown coloured areas with a central dark spot (the remains of the steel particles). The surface will feel like sandpaper, and the particle may be lifted with a fingernail. An old swarf stain will appear as a localised red-brown stain, the steel particle having corroded away, and the surface will be smoother.

Many swarf staining problems arise not only from installers, but also from following trades working in the vicinity (see Figure 1 for example). Architects, builders and project managers need to be aware of this possibility and warn contractors accordingly.

Figure 1: Swarf staining

Brush the surface with a stiff bristle (not wire) brush to dislodge particles which must then be completely removed, not just swept into the gutter. Care should be taken to avoid removing any metallic coating. If the metallic coating is severely damaged by swarf corrosion, the affected area should be replaced, or overpainted following the recommendations contained in:

Clean the surface by washing with dilute mild household detergent and fresh water, then rinse well afterwards.

1. The affected area should be thoroughly waterblasted with clean fresh water using a pressure not exceeding 400psi (2760kPa).
2. Stubborn particles may be removed by use of a damp microfibre cloth (terry towelling cloths or sponges are not effective). More stubborn particles may require a plastic-bladed paint scraper, if used with care.
3. Upon completion again wash the roof to remove any dislodged particles, ensuring gutters are also rinsed.
