Cut edge and bend protection of next generation ZINCALUME® steel and COLORBOND® steel

Technical Bulletin 10

January 2021. Revision 8.
This issue supersedes all previous issues.

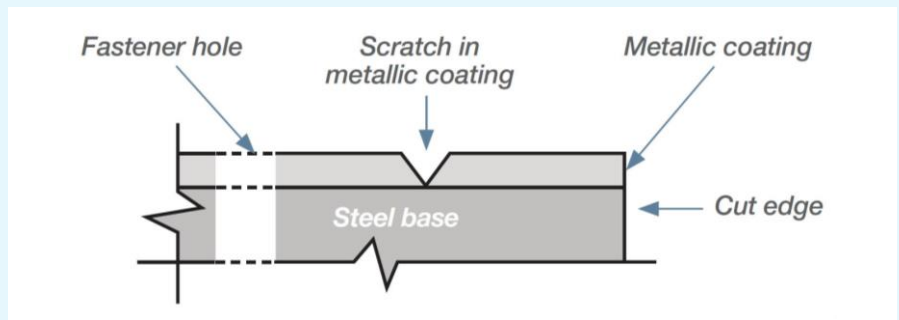
Figure 1: Schematic of a cut edge (not to scale)

Unprotected edges are created on coated steel products when the sheet is cut or pierced. Examples include when roofing or walling is cut to length or when holes are made in the steel to accommodate fasteners. It is normal practice to have edges that have been slit, sheared, drilled or cut on site using a cold cutting saw. *Figure 1* shows a schematic of a cut edge.

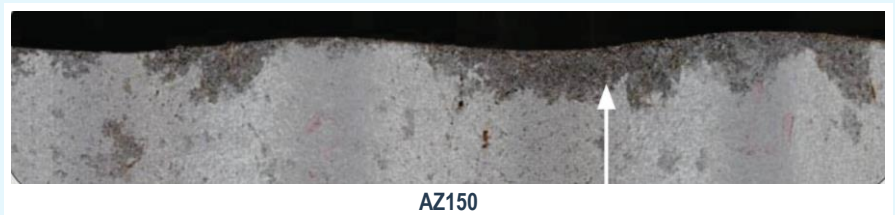
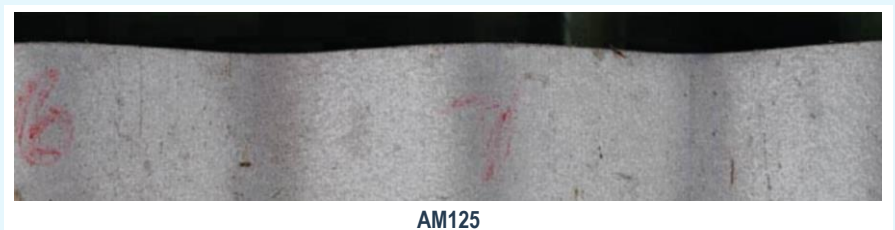
Figure 2: Unpainted sheltered walling (i.e. unwashed) in a severe marine environment after 50 months.

Dark areas indicate metallic coating originating from the cut-edge

NOTE: The samples shown in Figure 2 have been tested in a severe environment to accelerate corrosion rates. Use of the product in this location is not recommended by BlueScope.

For unpainted products, a combination of both coating mass and coating type determine how effectively a metallic coating is able to protect cut edges. In general, within a particular coating type, it can be said that the higher the coating mass, the greater the level of protection (e.g. AM150 provides a greater level of protection than AM125). However, different coating types can also have significantly different levels of protection. For example, next generation ZINCALUME® steel with Activate® technology provides a more effective means for protecting cut edges, and research demonstrates that AM125 is capable of providing better cut edge protection than AZ150. For further details about corrosion protection mechanisms, see [Corrosion Technical Bulletin CTB-6 Development of aluminium/zinc/ magnesium alloy coating for next generation ZINCALUME® steel with Activate® technology](#). Figures 2 and 3 demonstrate the greater effectiveness of cut edge protection by using AM125 metallic coating compared to AZ150 metallic coating.

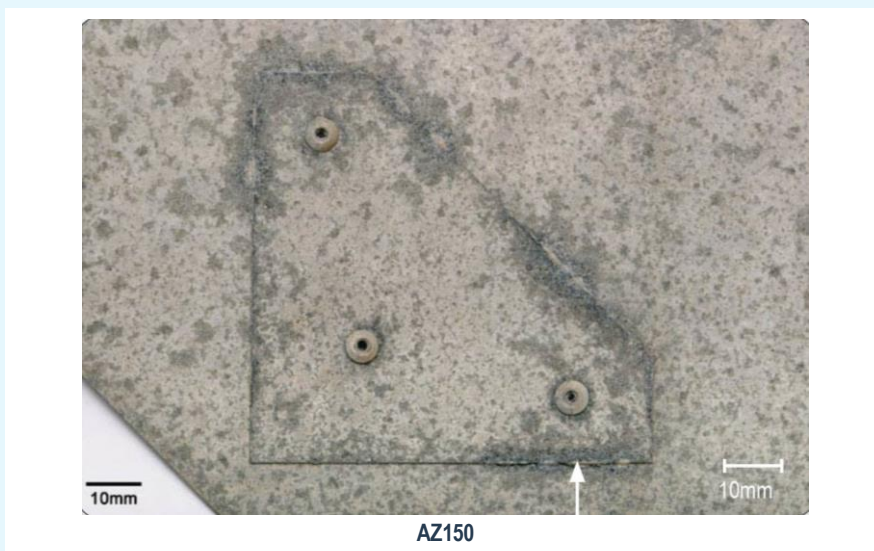
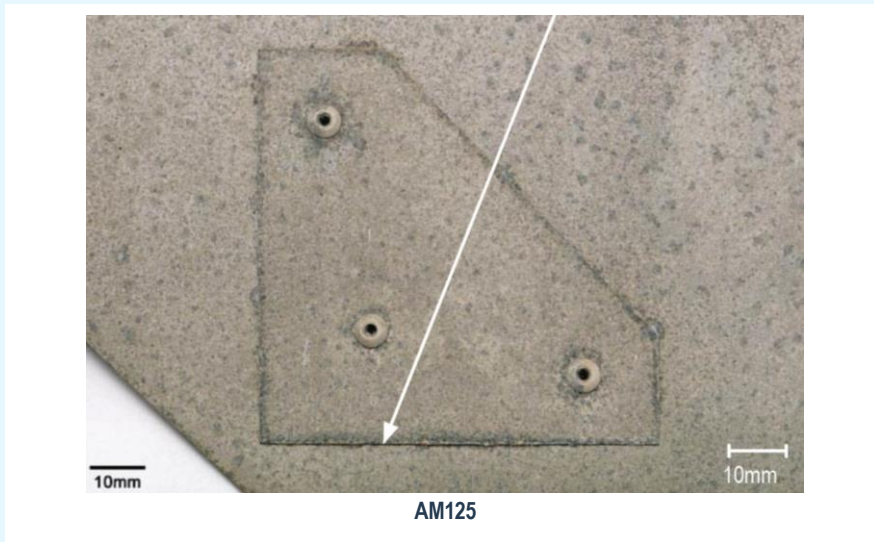
Figure 3: Unpainted panels tested in a sheltered (i.e. unwashed) position in a severe marine environment after 66 months.

Dark areas indicate metallic coating corrosion originating from the cut-edge.

NOTE: The samples shown in Figure 3 have been tested in a severe environment to accelerate corrosion rates. Use of the product in this location is not recommended by BlueScope.

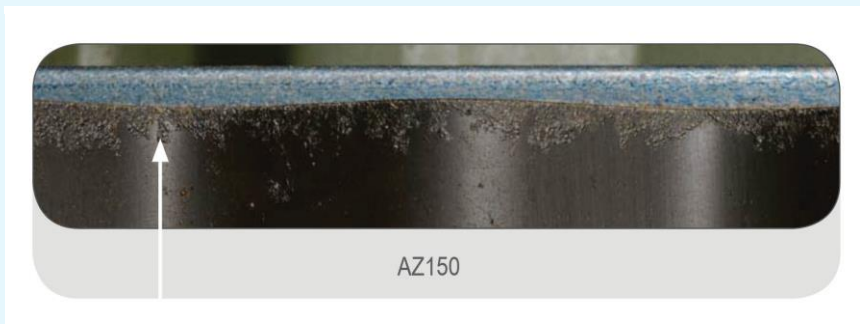
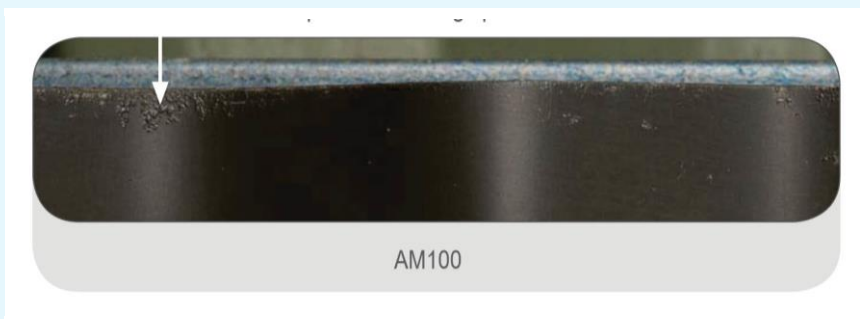
Figure 4: Prepainted sheltered walling (i.e. unwashed) in a severe marine environment after 50 months.

Blisters developed from cut-edge protection.

NOTE: The samples shown in Figure 4 have been tested in a severe environment to accelerate corrosion rates. Use of the product in this location is not recommended by BlueScope.

steel with Activate® technology provides an even more effective means for protecting cut edges. A reduction in metallic coating is able to be achieved without compromising the corrosion resistance at the cut edges of the prepainted product. This is illustrated in Figure 4.

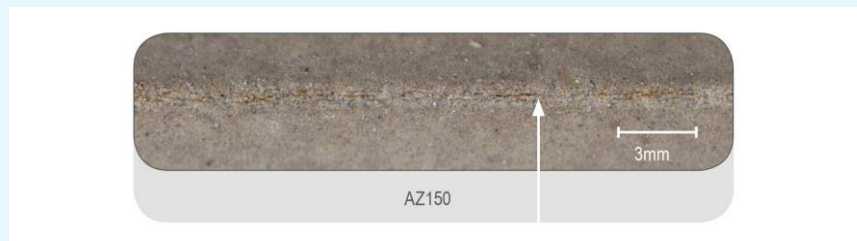
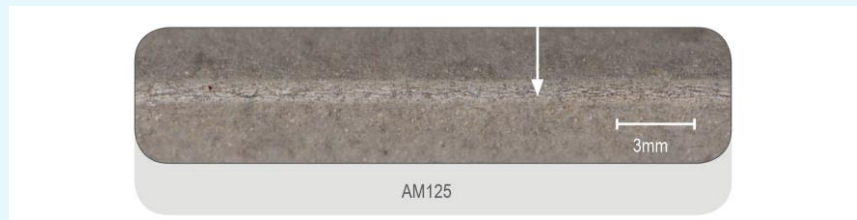
Figure 5: Close-up photographs of the 90° bend of unpainted samples exposed in a marine environment after 18 months (washed).

Close-up of 90° bend in the panel.

NOTE: The samples shown in Figure 5 have been tested in a severe environment to accelerate corrosion rates. Use of the product in this location is not recommended by BlueScope.

Extensive test programs have shown that the enhanced corrosion protection provided by the AM coating maintains either equivalent or superior field corrosion performance compared with AZ, even if the surface has superficial cracking. Figures 5 and 6 show samples that have been tested outdoors in marine environments to determine the difference in bend corrosion performance between AZ and AM.

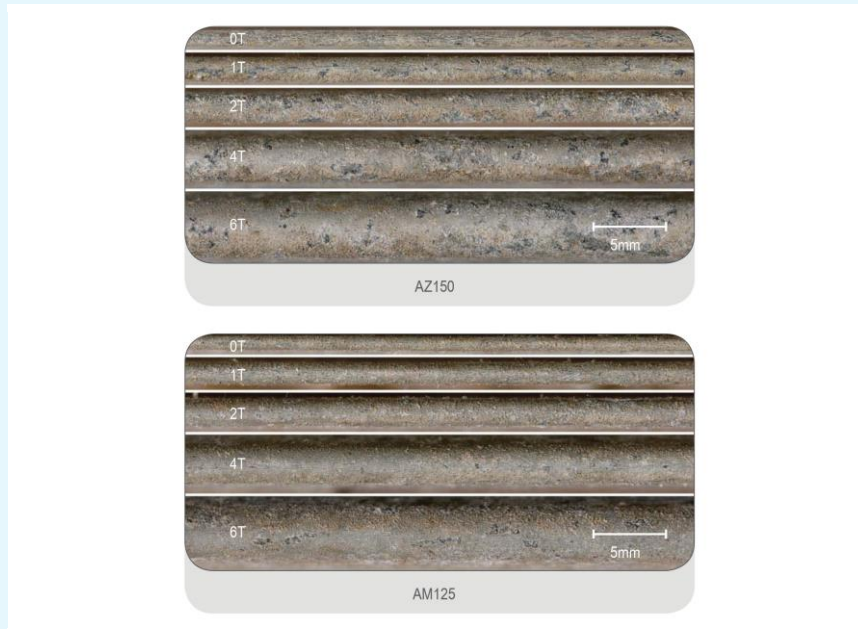
Figure 6: Unpainted samples of AZ and AM with various bend diameters, exposed in a sheltered (i.e. unwashed) severe marine environment for 45 months.

NOTE: The samples shown in Figure 6 have been tested in a severe environment to accelerate corrosion rates. Use of the product in this location is not recommended by BlueScope.

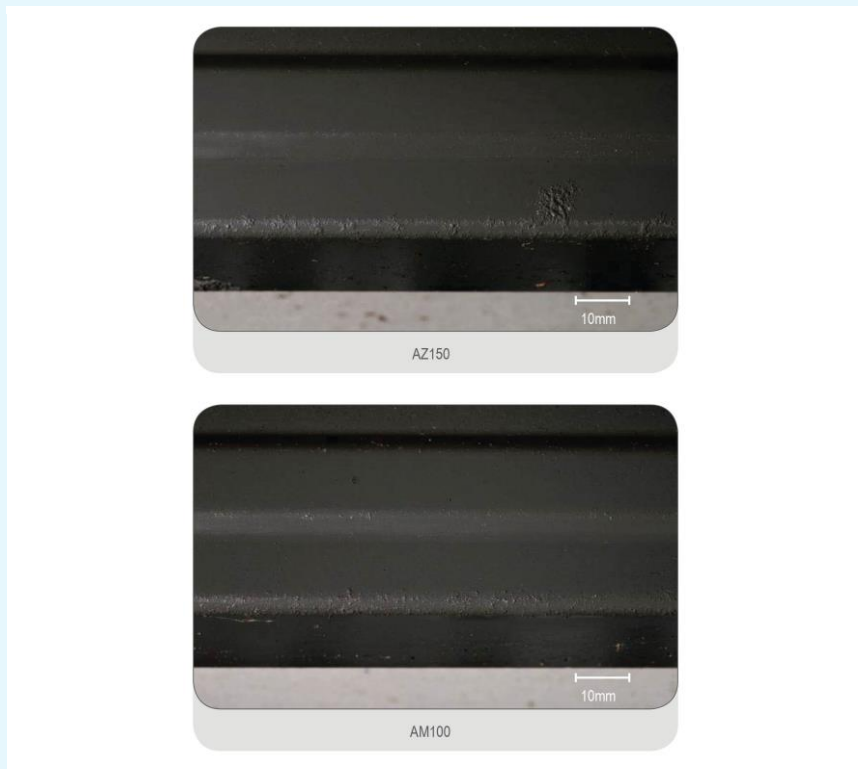
Figure 7: Prepainted, sheltered fascia bends (i.e. unwashed) after 57 months exposure within 100m from breaking surf on an outdoor test facility.

NOTE: The samples shown in Figure 7 have been tested in a severe environment to accelerate corrosion rates. Use of the product in this location is not recommended by BlueScope.

Bend corrosion performance on prepainted products is most relevant to applications with relatively tight bends that are also in unwashed areas. Figure 7 shows fascia samples of prepainted AZ150 and AM100 that have been tested in a severe marine environment for 57 months. Both samples show a number of very small blisters (visible at 10x magnification), with

additional intermittent larger blisters on the AZ150 product. It is important to note that the level of blistering seen in Figure 7 is not typically observed on either AZ or AM alloy coated steels in less severe environments. Figure 8 shows the results of a test to determine the corrosion

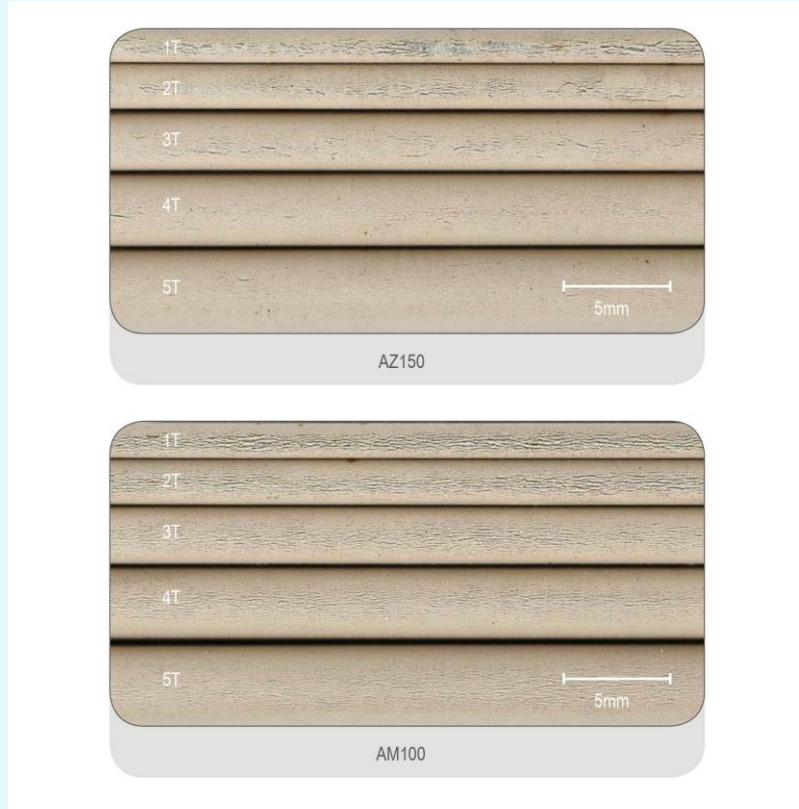
Figure 8: Prepainted bend samples exposed in an unwashed marine environment for 51 months.

performance of prepainted AZ150 and AM100 with a range of bend radii, exposed for 51 months in an unwashed marine environment. Whilst there is slightly more cracking on the AM100 product, there is a minimal corrosion on either the AZ150 or AM100.
